# Bajo de Mina Hydroelectric Project

## Chiriqui, Panama (2011)

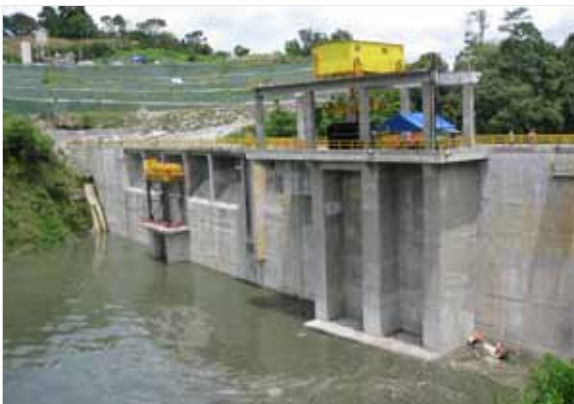
**The completed Bajo de Mina Dam produces 36 MW of energy per day.**

The conduction tunnel received the same crack repair and T1 & T2 waterproofing treatment. The repaired Bajo de Mina Dam now supplies a stable 36 MW of energy per hour for the region.

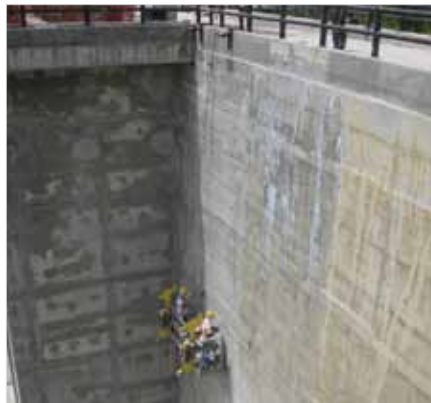
Originally the construction team used RCC (Roller Compacted concrete) to construct the 30 m tall (98 ft.) dam face. During construction leaks appeared at all the cold joints along the face formed by the RCC layers. Along with this, leaks from the mountain water run-off appeared in the conduction tunnel ceiling.

**Kryton's Krystol Crack Repair System was used to repair leaks in the dam face.**

When Kryton's distributor Tecnosagot, was brought on board to repair the leaks, the dam face was already 50% complete. The applicator used Kryton's Krystol Crack Repair System to repair all the leaking joints across the dam face, then the whole area was coated with Kryton's T1 & T2 Waterproofing System. The final part of the dam face was completed using Kryton's Krystol Internal Membrane (KIM) admixture.
